Manhole Inspection Summary

Manhole # S21E__019MH

Insp Date: **8/16/07 1:05 PM**

Location Address: **1738 SARATOGA-LEXINGTON**

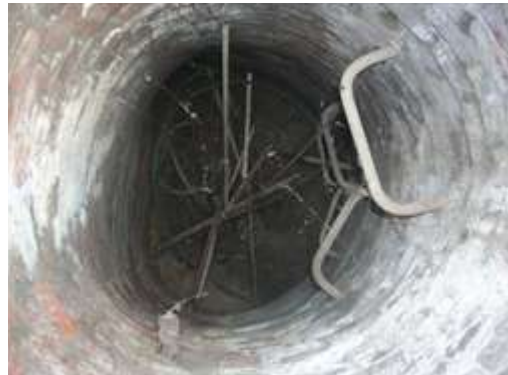
Top View

A LOT OF DEBRIS

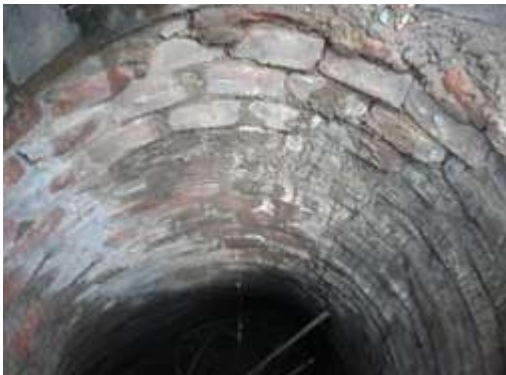
Defect 2

Infiltration: ☐ None ☐ Joint ☐ Cracks ☐ Mortar ☐ Roots ☒ Wall

INFILTRATION: CORBEL WALL

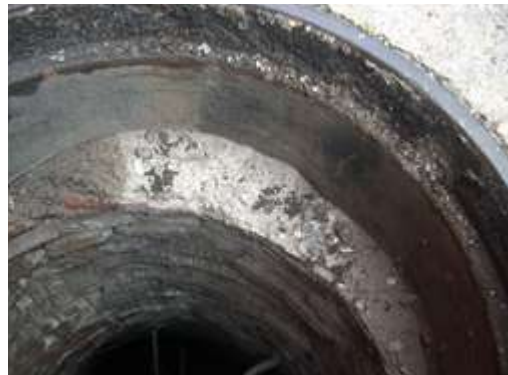
Defect 1

Offset: **2** (in.)

FRAME OFFSET

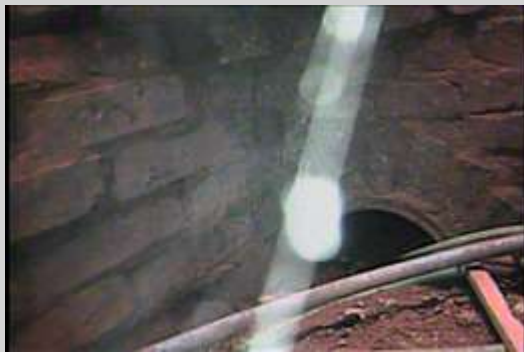
12 O'Clock Outflow

8 in. Circular Gravity Sewer
Pipe Out @ 12 O'Clock

Deposits: ☐ None ☐ Mud ☐ Sludge ☒ **Debris** ☐ Grease

Silt Depth: **3** (in.) Deposits Extent: **Medium**
